TECHNICAL TROUBLESHOOTING GUIDE

WATERPROOFING, FLOORING & ROOFING CAUSE, REPAIR & PREVENTION

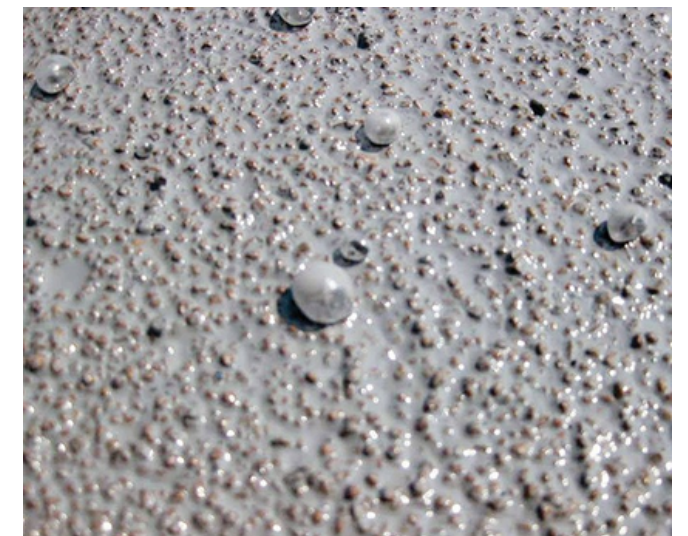
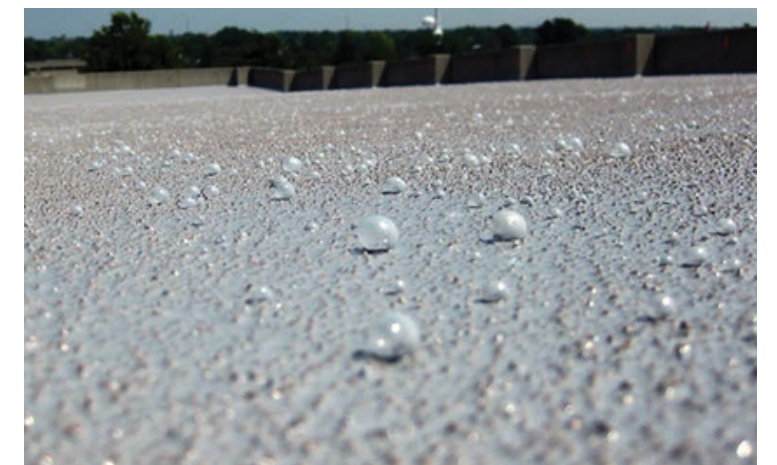
PINHOLES DUE TO OUTGASSING

Pinholes are small diameter holes in the coating that are readily visible. When these blisters pop they usually leave a round crater and the pinhole should be easily seen through the transparent film. They may be randomly dispersed or concentrated to a certain area of the coated surface.

- Concrete releases air and moisture vapor that expands as temperatures rise.
- Aggressive shot-blasting or scarifying opens concrete pores and bug holes.
- Air entrapped in wear coat when aggregate is applied too heavy, leaving entrapped air pockets.
- Introducing air into coating during application with aggressive rolling.
- Using improper roller cover with too large nap can introduce air into coating.
- Introducing air into coating during mixing by using wrong mixing paddle or too high rpm power drill.
- Over accelerating the coating. Air from the substrate or chemical reaction with the coating cannot escape properly during the curing process.
- Adding solvents can result in surface pinhole blisters if the solvent is not allowed to escape prior to gel/cure.

The blisters need to be broken with a stiff bristle broom or squeegee before another coat is applied. A light abrasion may be required to maintain good aesthetic appeal. Large areas of pinholes may need to be ground with a cup grinder and additional coating applied.

- Begin application as temperatures are dropping and continuing to drop. Rising temperatures result in detrimental expansion of the moisture and air in the concrete. Falling temperatures do the opposite; the air and moisture are contracting within the concrete.
- Double prime or increase slightly the amount of primer being used for the system.
- Apply the specified system in thinner coats. Obviously, this procedure means more coats are involved in applying the full system.
- Thin the material being used in the first base coat. Use only commercial grade solvents and never thin products more than 10% by volume. Excessive thinning may affect physical properties of the coating.

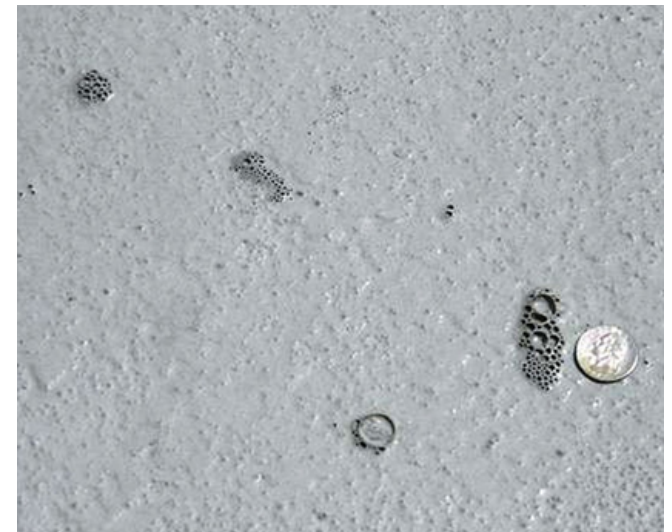
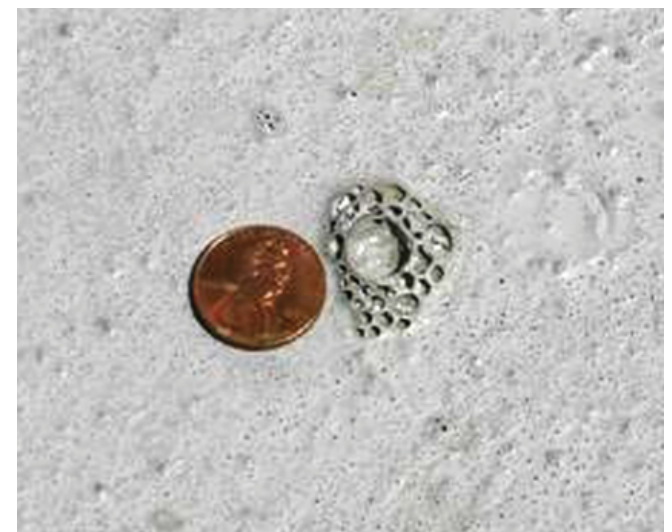
PINHOLES/CRATERS DUE TO MOISTURE CONTAMINATION

Pinholes due to moisture will occur in clusters and may rupture and form craters.

Moisture or moisture contaminated aggregate will react with the coating material and cause a bubbling effect as shown above. This is caused by a chemical reaction between the moisture and the coating material.

Grind affected areas smooth and apply additional coating to match adjacent areas.

- If the deck is contaminated with moisture between coats from rain, dew, sprinklers, a/c equipment, etc. make sure the deck is completely dry before coating.
- Keep aggregate dry by storing in a covered area.
- Install aggregate wear coat in accordance with recommendations. Pinholes may develop if aggregate is installed at rates greater than recommended and can be a source of moisture contamination.
- Ambient temperature should be more than 5o above dew point. Refer to Dew Point Chart in the Waterproofing Application Manual for ambient temperature and relative humidity guidelines.

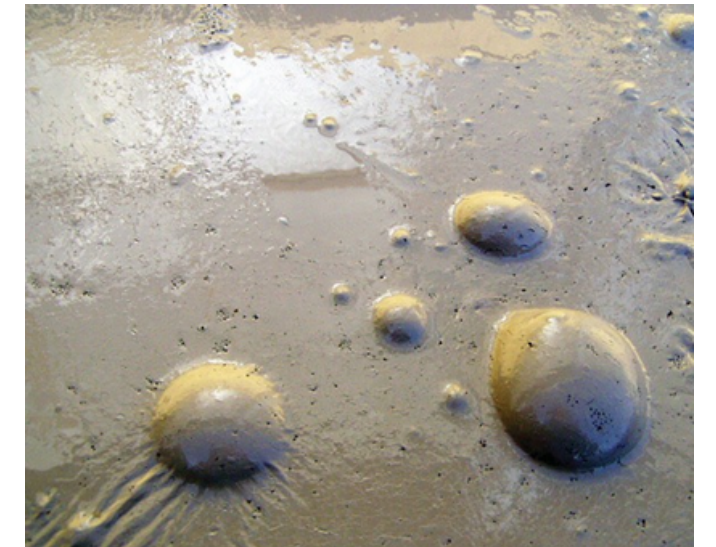
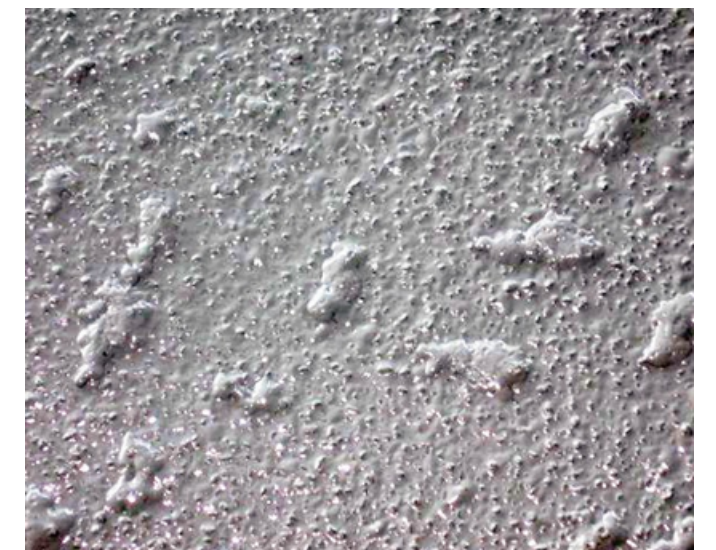
BLISTERING DUE TO WATER CONTAMINATION

Blisters look like small to large unbroken/broken bubbles in the coating surface and are readily visible. They are typically randomly dispersed in the coated surface.

Water from rain or dew mixed or rolled into wet, uncured coating. The coating reacts with the water and attempts to cure on the top, forming blisters and stress wrinkled areas. The blisters will have a trace of water or moisture trapped inside them. Moisture between the aggregated wear coat and topcoat leaves an orange peel texture on the backside of the blister mirroring the sand coat texture.

- Cutout and remove all blistered and wrinkled areas.
- Grind affected areas to sound coating.
- Allow to dry thoroughly.
- Reapply coating as need to bring system to specified thickness.

- Do not apply coating if rain is imminent.
- Ambient temperature should be more than 5°C above dew point. Refer to Dew Point Chart in the Waterproofing Application Manual for ambient temperature and relative humidity guidelines.

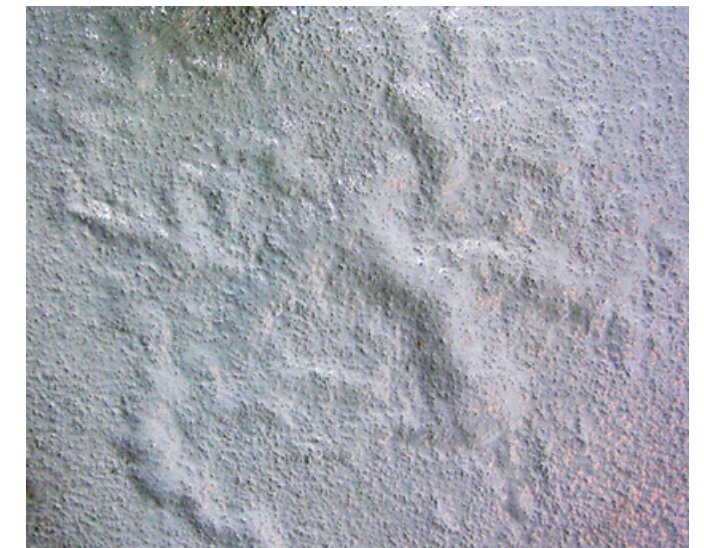
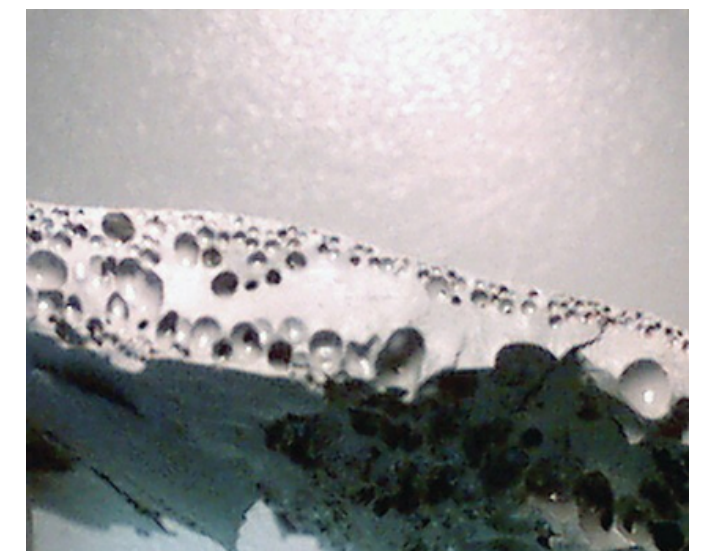
BLISTERING DUE TO THICK COATING

Blisters look like small to large unbroken bubbles in the coating surface and are visible to the naked eye. They are typically randomly dispersed in the coated surface.

Coating blisters can be the result of coating being applied at a rate greater than application instructions. They can appear as round or oblong blisters and depending on the state of cure, can feel spongy or uncured beneath the surface when examined.

Affected areas need to be completely removed down to cured coating or substrate. Reapply coating system per specifications and recommendations.

- During installation of coating, frequently check the wet film thickness by use of recommended mil gauges. Also, laying out the job prior to coating by gridding out the area will help to maintain proper and uniform coating thicknesses.
- During application, double roll to limit low spot areas where the self-leveling coating may 'pool'.

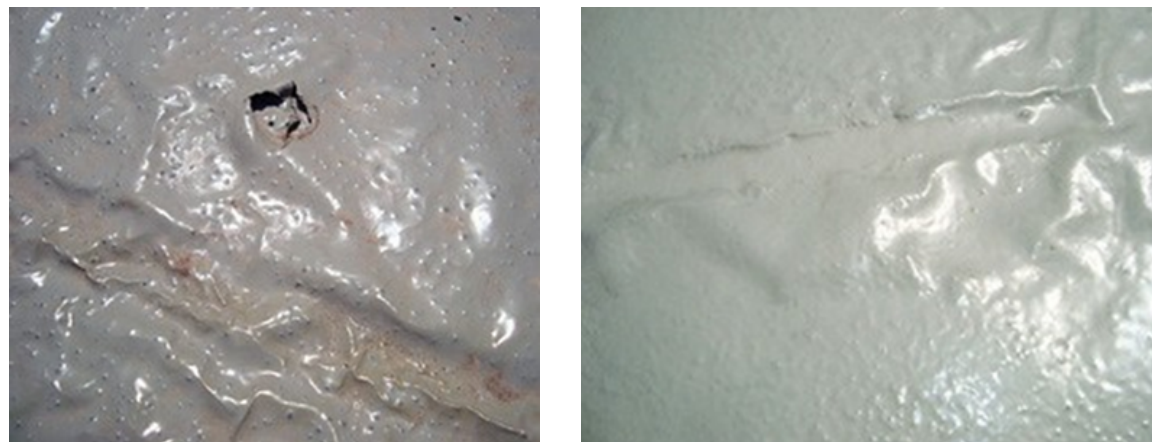
WRINKLING

Coating looks wrinkled in places.
Multiple lines of parallel wrinkling may occur.

- Material applied over uncured or off-ratio coating causing stress on topcoat.
- Coating applied at a thickness that exceeds application instructions.

Remove coating in affected areas to cured coating or sound substrate. Apply coating as specified and per recommendations.

- Ensure that coatings are completely cured prior to proceeding with the application of additional coats.
- Apply coatings at recommended coverage rates.
- Mix all materials thoroughly, following mix ratios printed on the bucket labels or on the product data sheet.

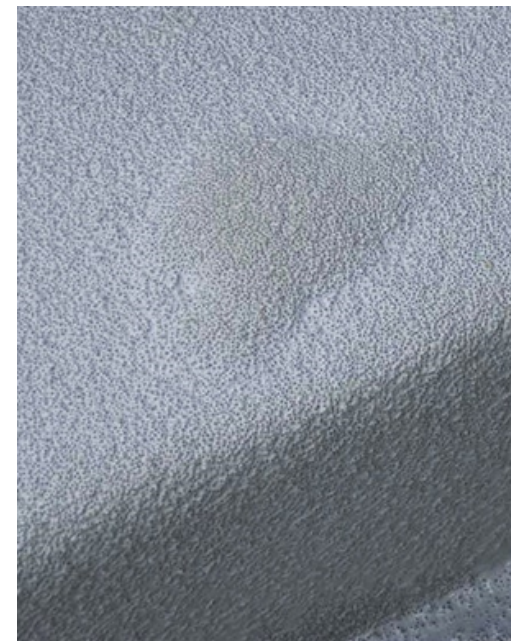
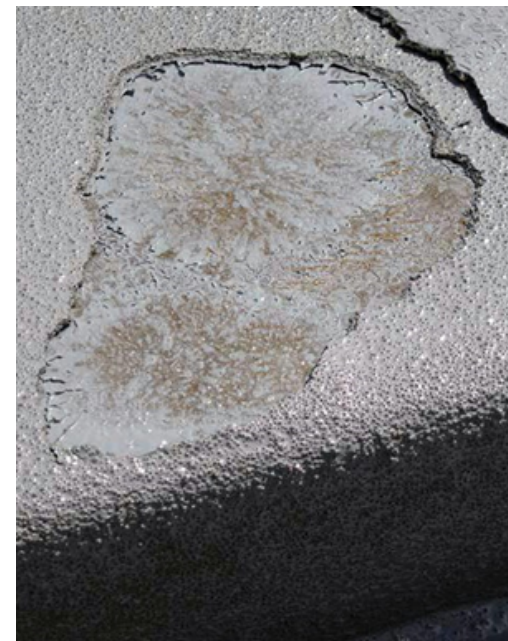
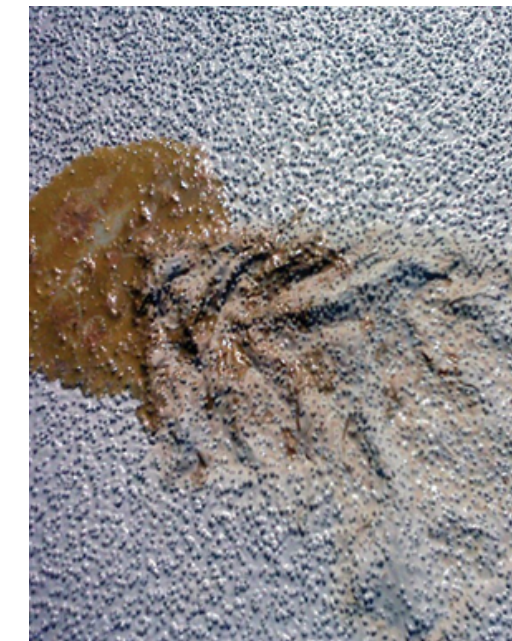
SLOW / NO CURING

Coating is soft and may transfer when touched. Coating may also delaminate.

Photo on left illustrates typical blister. Center photo is the area beneath the removed blister, showing a pattern of uncured coating. Photo on the right shows topcoat applied over uncured base coat that was off ratio, in a semi-liquid state, causing tension and wrinkling in the topcoat.

Cut out blister to sound, clean substrate. Solvent wipe to remove all residue. Grind down edges for a smooth transition. Ensure all edges are totally bonded leaving no fish mouths or air gaps. Re-apply system.

Ensure that the previous coats are on ratio and allow previous coats sufficient time to cure prior to applying additional coats.

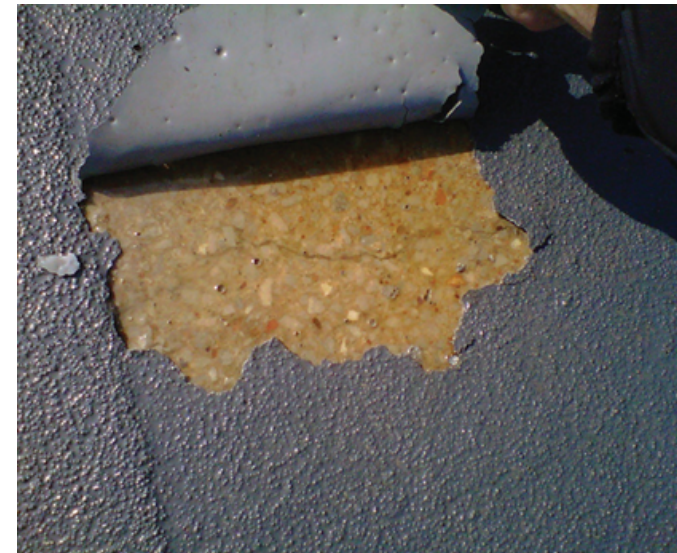
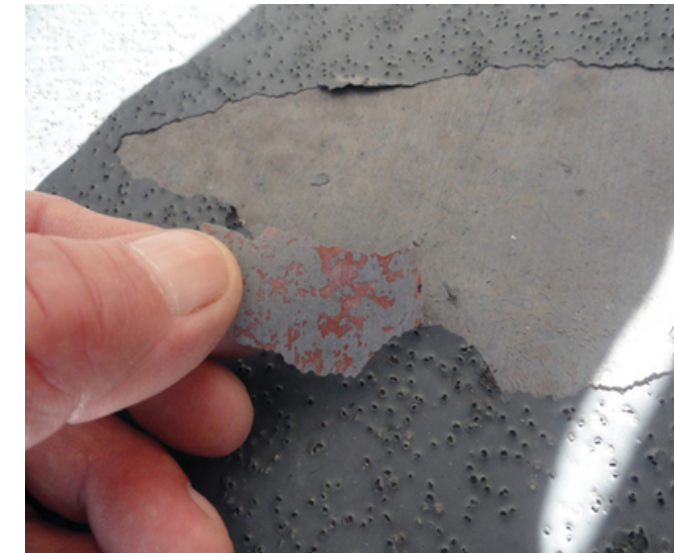
PEELING / DELAMINATION

Premature failure of coating can occur through delamination. Coating may peel off in places and show signs of laitance on backside.

Delamination may be caused by improper surface profile, moisture, contamination from dirt, dust, concrete residue etc., and incompatible materials. The picture on the left shows the use of an epoxy primer that was coated after the 24-hour window or exhibits the presence of 'blush' due to moisture or high humidity. The picture on the right demonstrates delamination due to insufficient surface preparation; surface texture does not meet the requirements for good bonding and was not clean and free from laitance.

Remove loosely bonded material, abrade, clean and re-apply material as specified and per Adcrete recommendations.

- Base coat must be applied within 24 hours of primer application. If base coat application window is missed, clean surface and re-apply primer.
- If high humidity has caused the primer to 'blush', solvent wipe surface before proceeding with application of coatings.
- Properly prepare surface by mechanically abrading to remove surface contamination or concrete laitance. Surface should ideally be shot-blasted to the required surface texture (CSP3 to CSP4) to allow for optimal bonding.
- Perform field adhesion test prior to application of the coating.

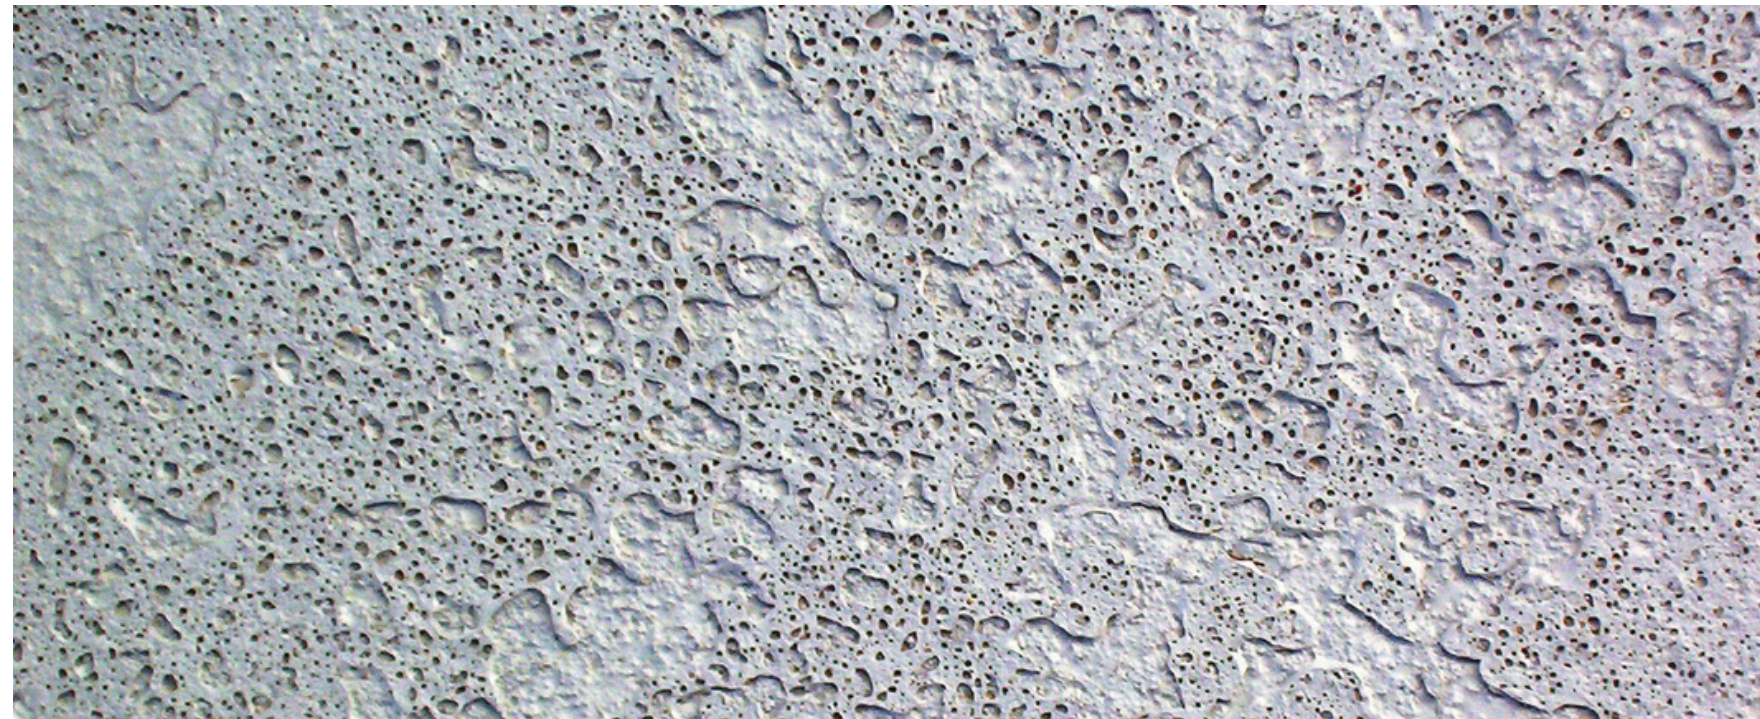
WATER DAMAGE TO CURED COATING

Surface has areas of dull coating in random patterns where water has meet uncured coating.

This is heavy rain or water damage that occurred to uncured coating.

Grind all affected areas to eliminate ridges in these cratered areas, clean and allow to completely dry. Re-apply coating as specified and in accordance with Adcrete recommendations. In severe situations, the coating may have to be totally removed prior to re-coating.

Do not apply coatings if rain is imminent. Ensure sprinkler systems are disabled for duration of the project.
